CUMMINS 600 HP HEAT EXCHANGER DESCALING

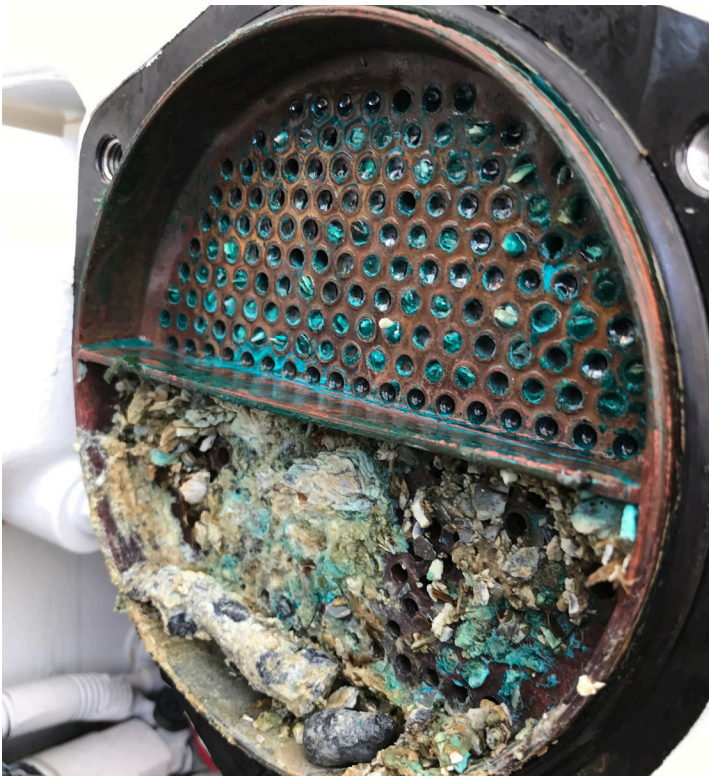
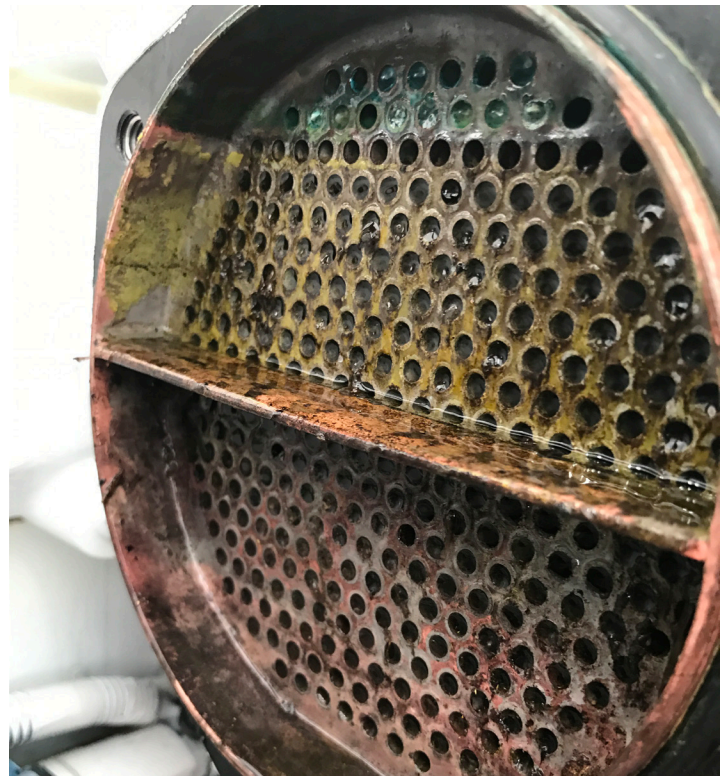
These 2 Cummins 600 hp diesel engines were experiencing temperatures of over 200°F! Upon further inspection, it was noted that the heat exchangers were fouled with scale and marine growth. **RYDLYME Marine** was then added to the heat exchanger top with the bottom plugged. As the solution dissolved the water scale and marine growth, more **RYDLYME Marine** was added to the heat exchanger. After several hours of static cleaning, the water scale was completely dissolved! Temperatures are now at a respectable 168°F!

Water scale was creating cooling issues on 2 Cummins diesel heat exchangers - having them run at over 200°F!

A solution of **RYDLYME Marine** was added to the heat exchangers and cleaned statically for several hours.

After the **RYDLYME Marine** cleaning, the heat exchangers were completely cleaned allowing the engine to run at a cool 168°F!
